Public works (1914) Department.

Photograph of a Syphon well drop in the Palayamparavoo channel ——
Furnishing the Government of India with eight unmounted copies of ——

Photo of Syphon well drop in the new Palayamperavo Channel - Forwards a — with a request to be informed if any more Copies & the negative are required.

Syphon well drop in the new Palayamperavoo channel. Forwarding report in connection with the ——.

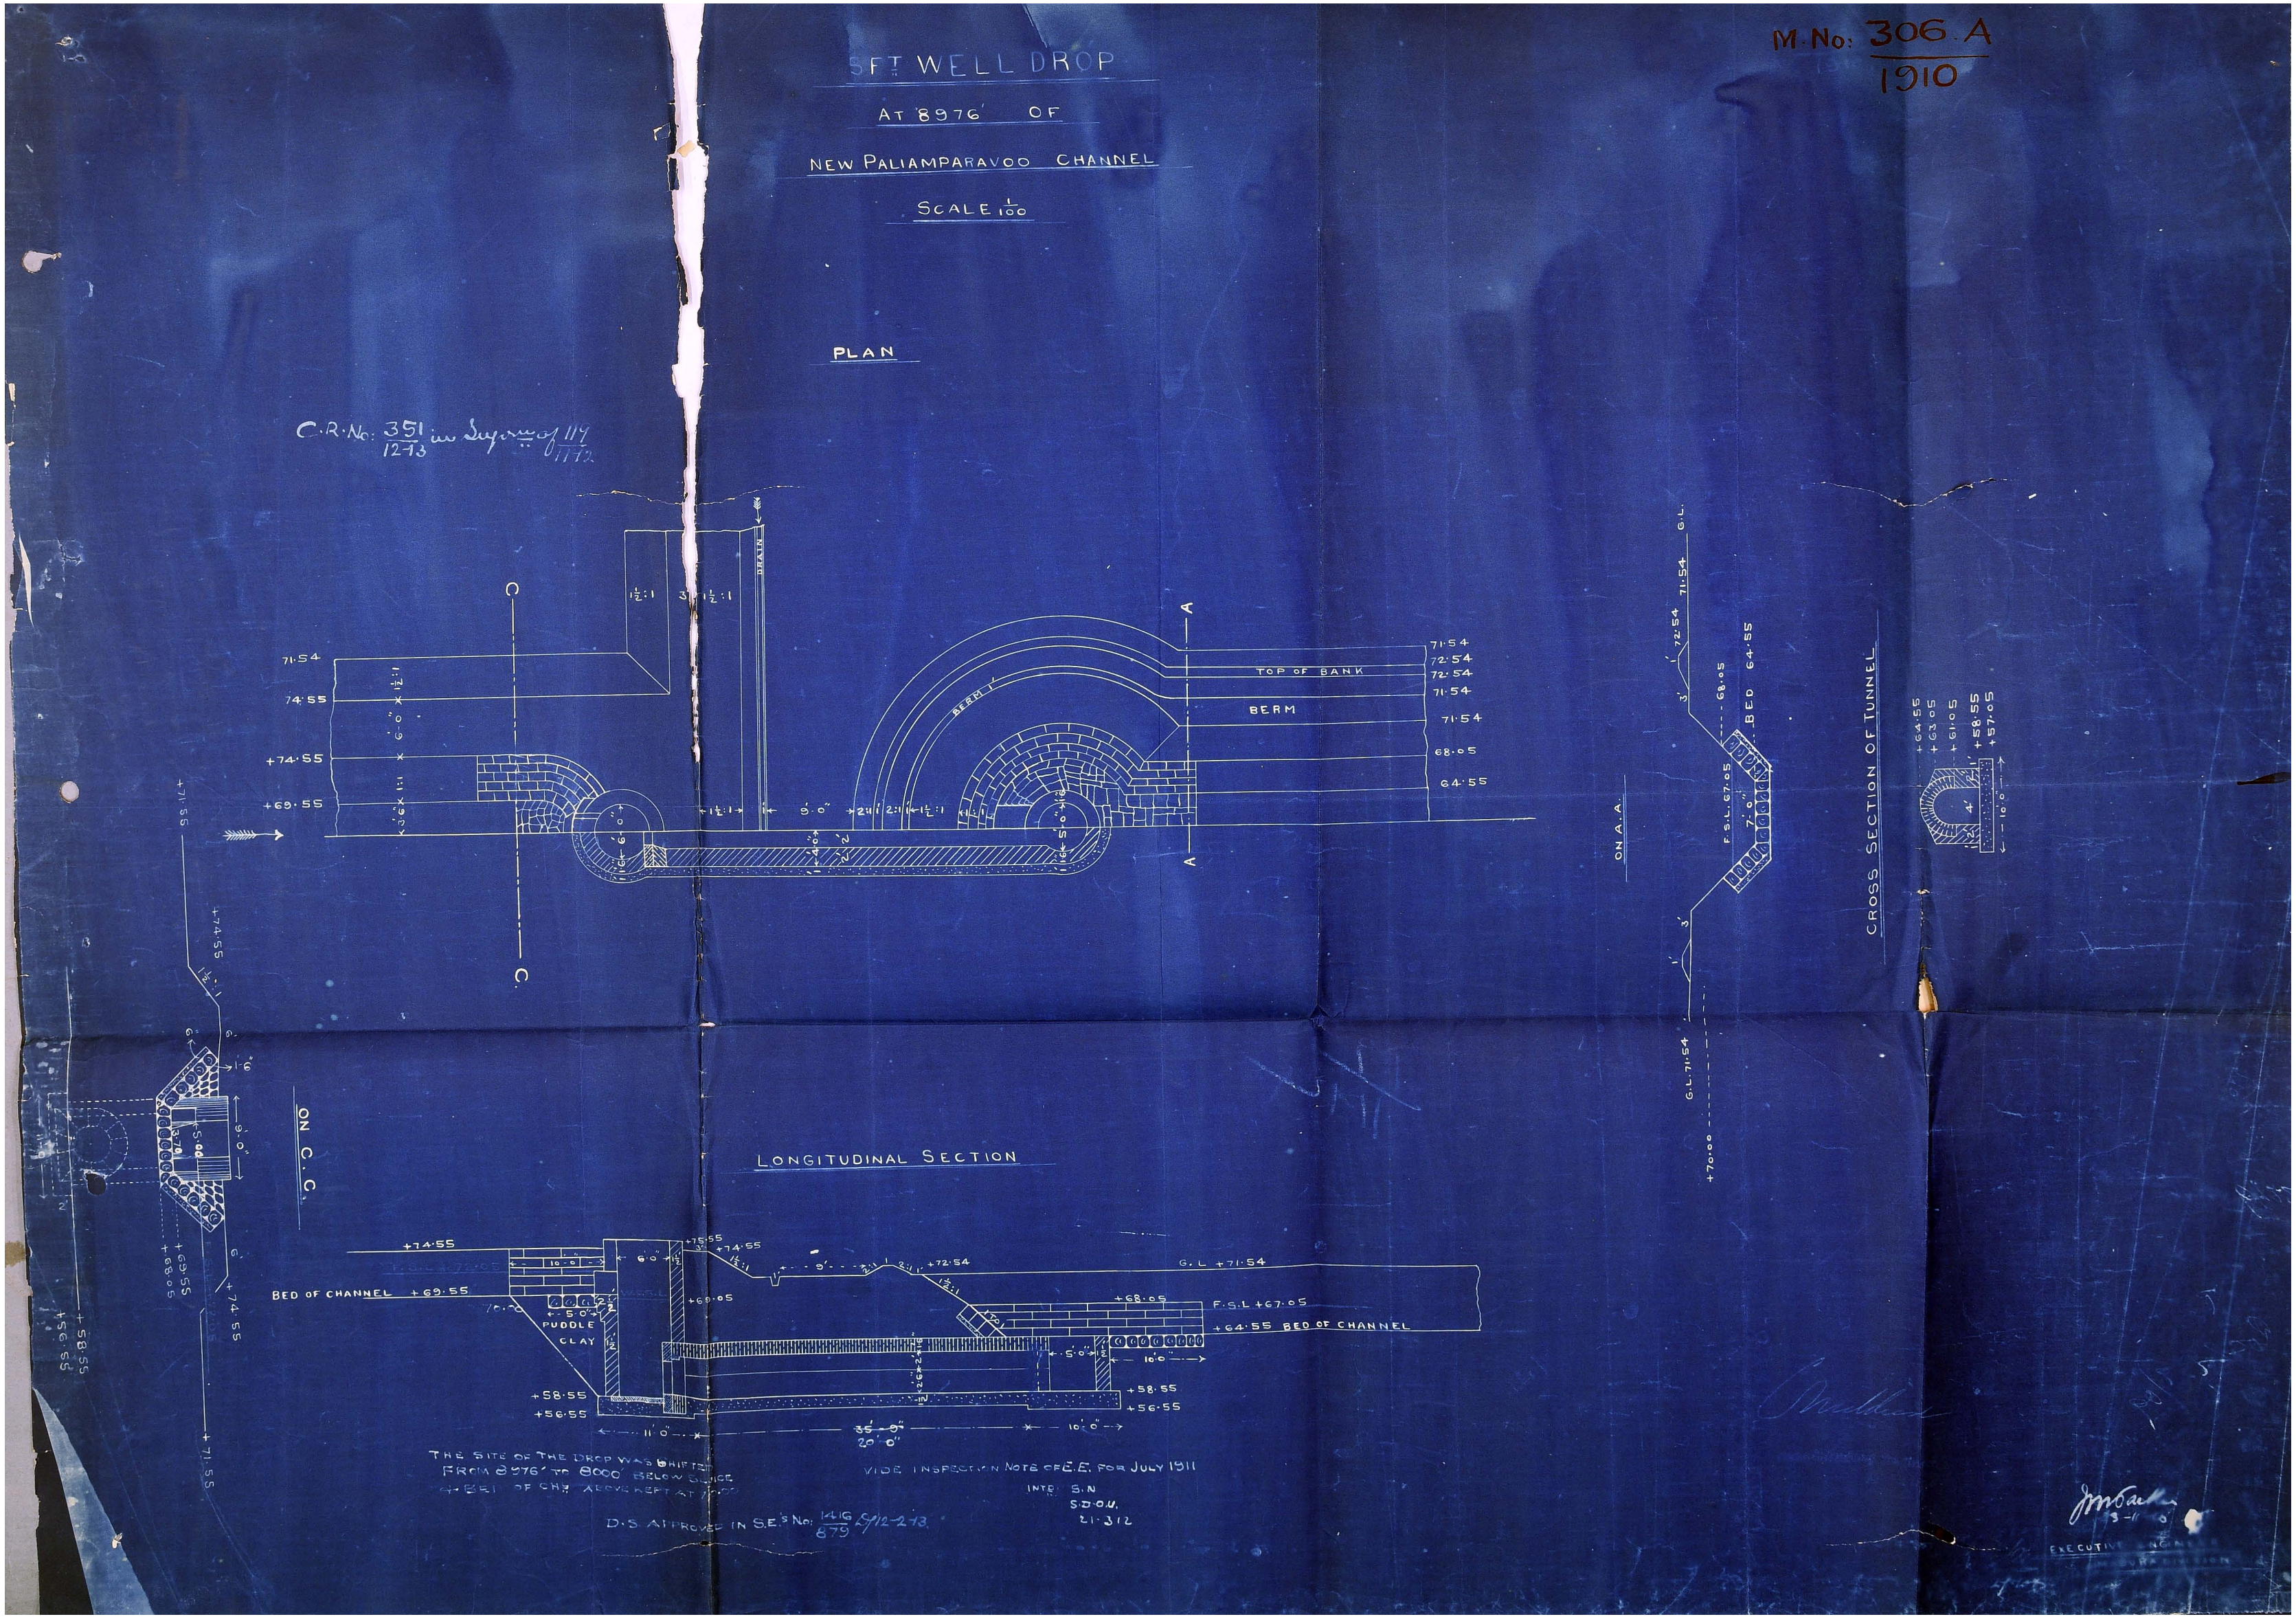
2. The erosion in rear of the well drop may or may not be attributable to the new work. It probably is not. The -- channel was dug in 1908 and the drop built in 1912. There is wet cultivation all round the site and water is always percolating into the channel below the drop causing slips. The revetment below the drop was not well built and was not taken high enough. If it were taken about another 1'-6" higher much of the scour would be stopped.

3. The entry to the well is a trapezoidal notch in the side of the well. On the day the photo was taken a little water was probably passing over the top of the notch; on this account probably the notch did not appear clearly in the photo.

4. The width of the earthwork behind the well is sufficient for cart traffic and carts are reported to pass that way now.

M. No: 306 A
1910
5 FT WELL DROP
AT 8976' OF
NEW PALIAMPARAVOO CHANNEL
SCALE 1/100
PLAN
C.R. No: 351/1213
TOP OF BANK
BERM
DRAIN
ON A.A
CROSS SECTION OF TUNNEL
ON C.C.
LONGITUDINAL SECTION
BED OF CHANNEL +69·55
PUDDLE CLAY
G.L +71·54
F.S.L +67·05
+64·55 BED OF CHANNEL
VIDE INSPECTION NOTE OF E.E. FOR JULY 1911
D.S. APPROVED IN S.E.'s No.
EXECUTIVE
